Reference
No.: 9289-019

SURVEILLANCE

AND INSPECTION REPORT

Project Name: Botanical Estate, Stage 27

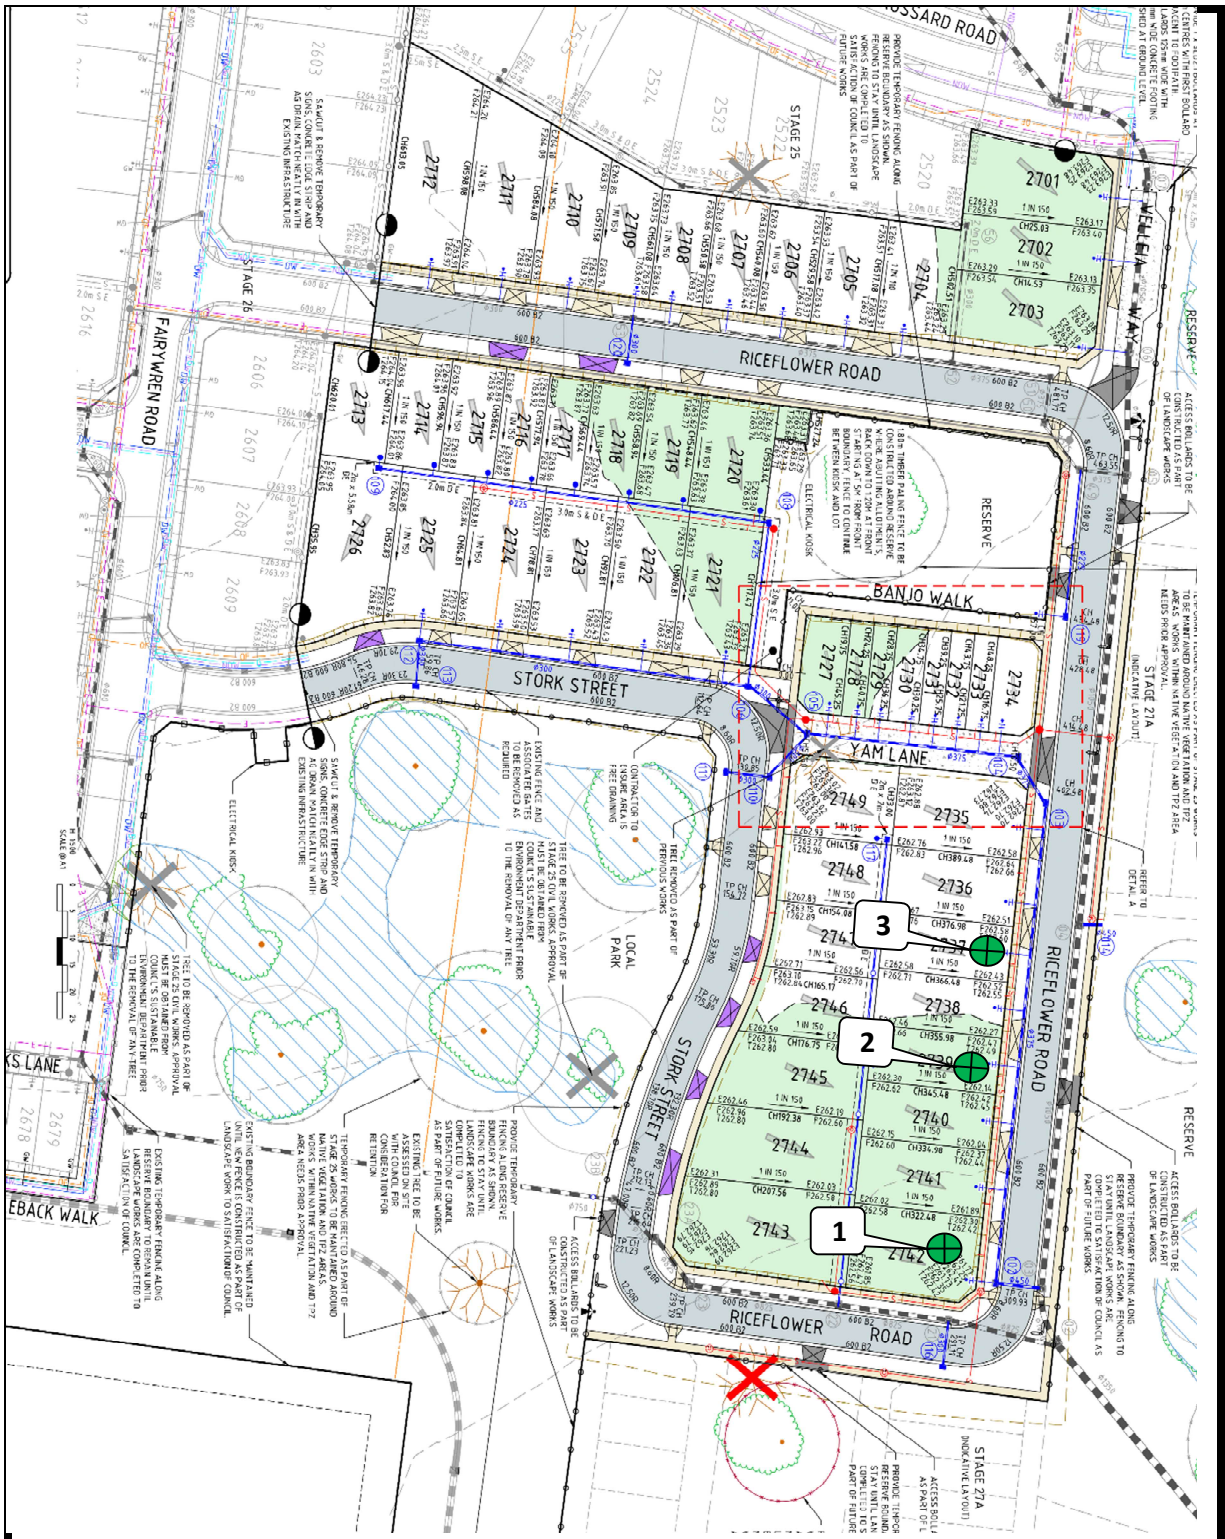
GEOTECHNICAL LABORATORIES	GEOTECHNICAL LABORATORIES ACN 102 571 077 14 Ravenhall Way, Ravenhall, Vic 3023 Email: info@geolab.com.au Phone: (03) 8361 9140	
	CLIENT: SYMON BROS LOCATION: Botanical, Stage 27 Sketch indicating compaction test locations	DATE: 27/02/2025 OPERATOR: CC/MU SCALE: NTS

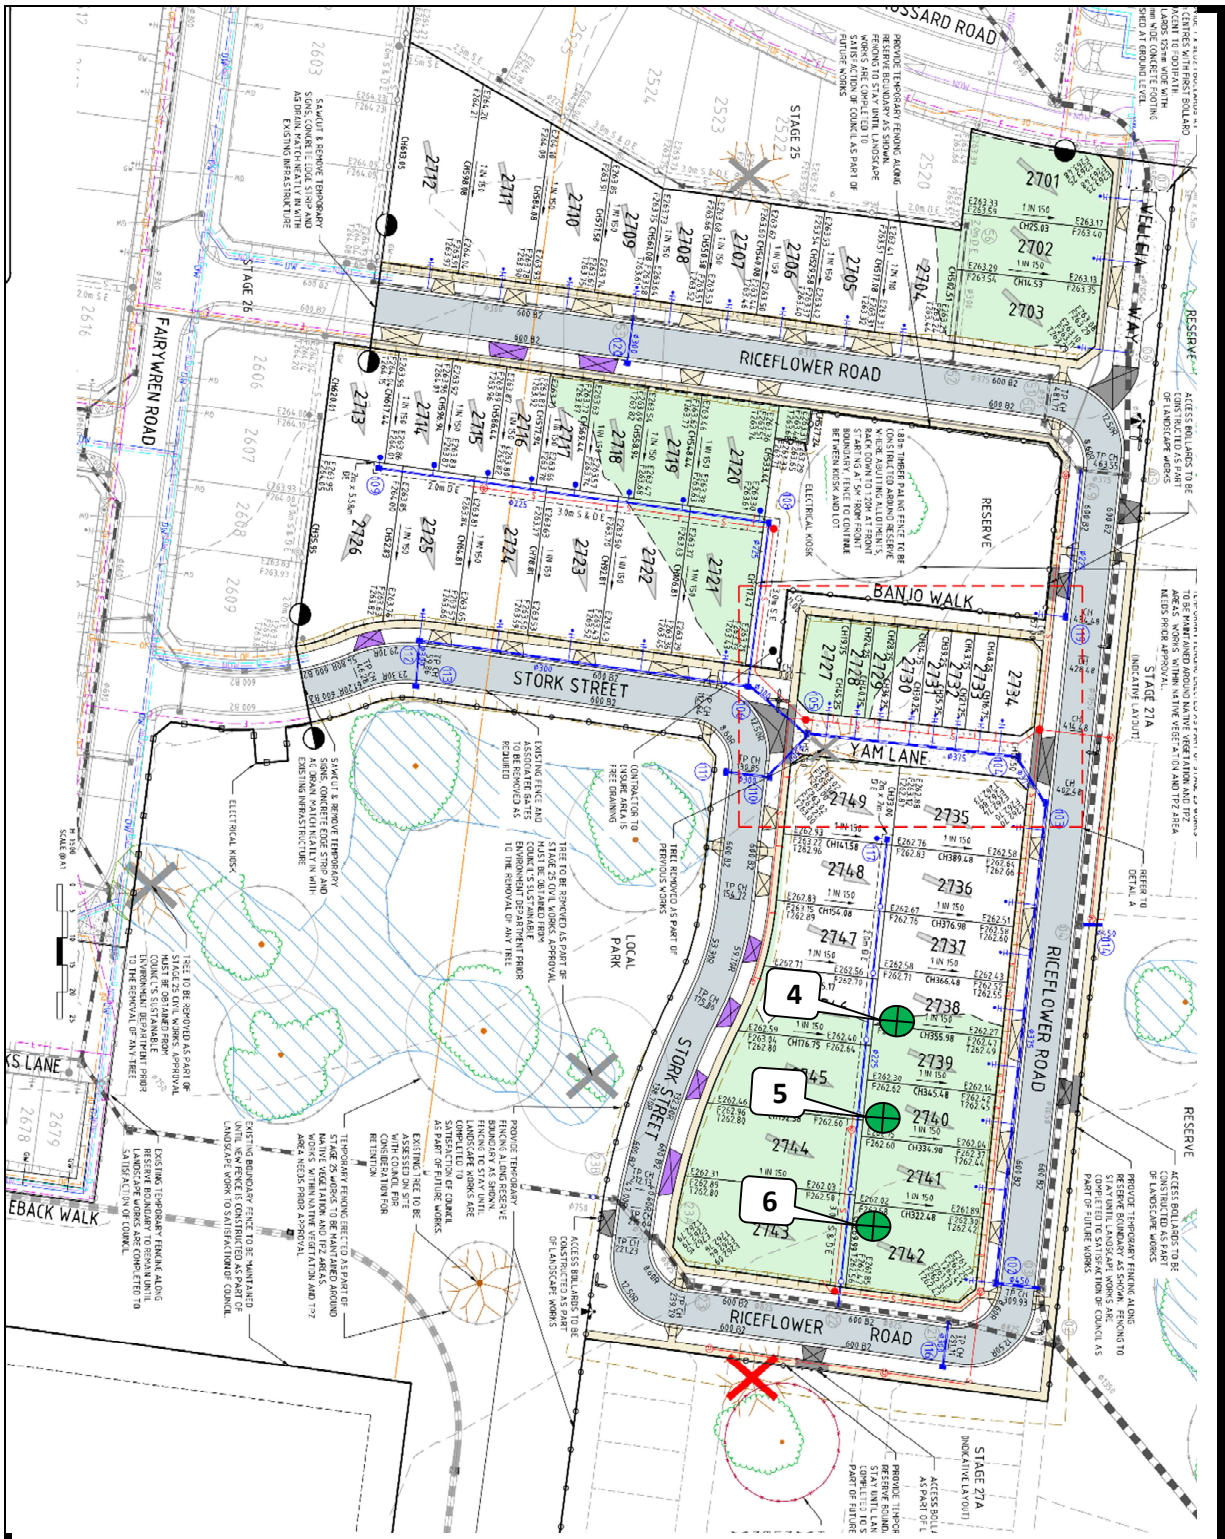
GEOTECHNICAL LABORATORIES	GEOTECHNICAL LABORATORIES ACN 102 571 077 14 Ravenhall Way, Ravenhall, Vic 3023 Email: info@geolab.com.au Phone: (03) 8361 9140	
	CLIENT: SYMON BROS LOCATION: Botanical, Stage 27 Sketch indicating compaction test locations	DATE: 28/02/2025 OPERATOR: CC/MU SCALE: NTS

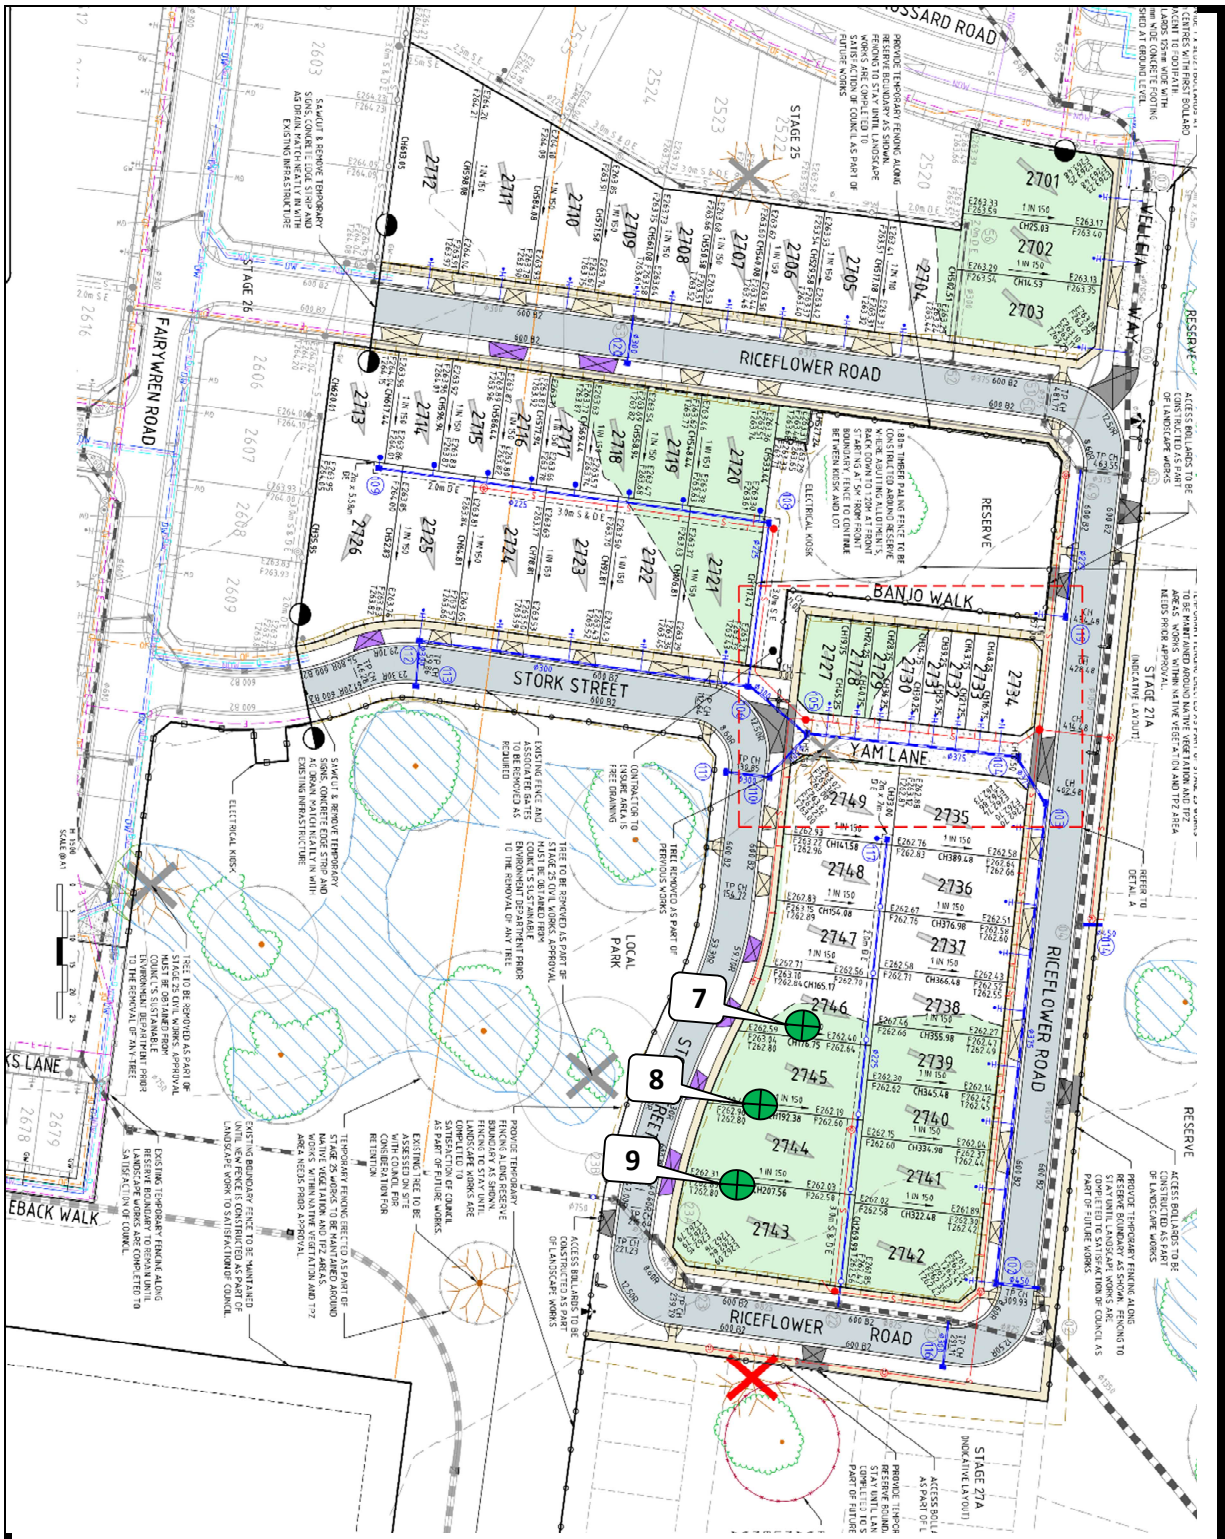
GEOTECHNICAL LABORATORIES	GEOTECHNICAL LABORATORIES ACN 102 571 077 14 Ravenhall Way, Ravenhall, Vic 3023 Email: info@geolab.com.au Phone: (03) 8361 9140	
	CLIENT: SYMON BROS LOCATION: Botanical, Stage 27 Sketch indicating compaction test locations	DATE: 3/03/2025 OPERATOR: CC/MU SCALE: NTS

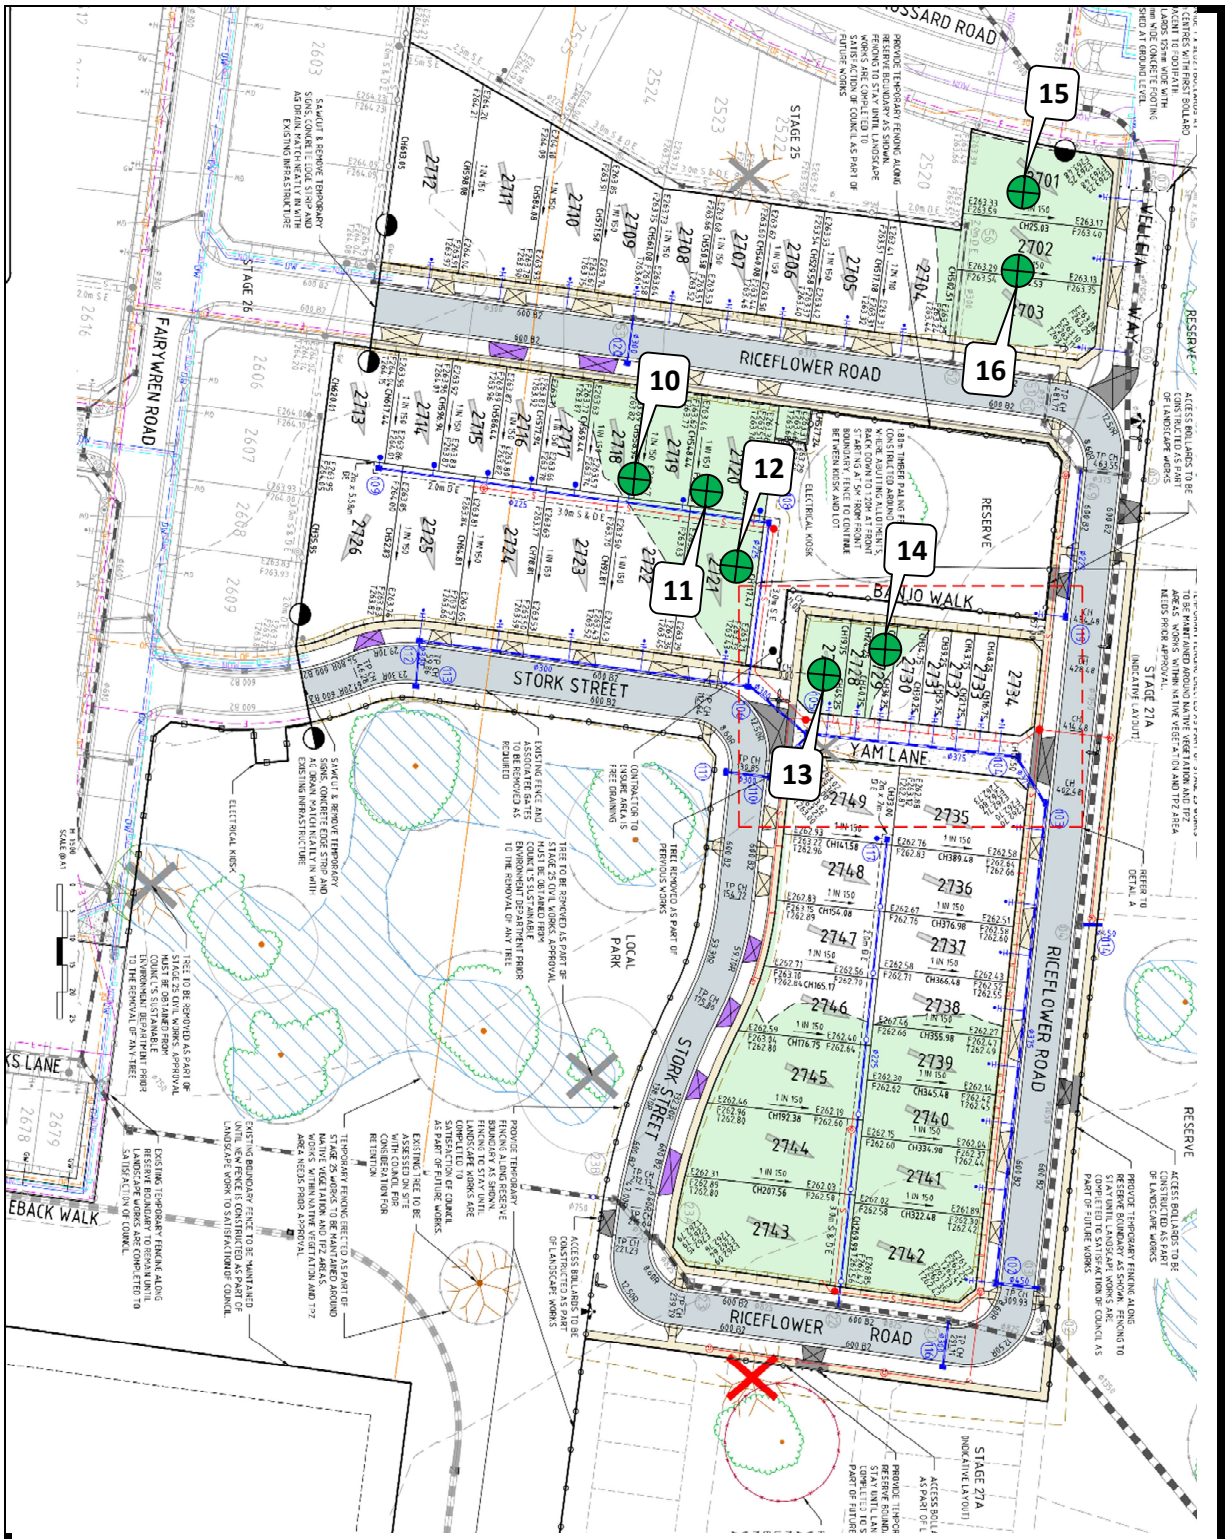
GEOTECHNICAL LABORATORIES	GEOTECHNICAL LABORATORIES ACN 102 571 077 14 Ravenhall Way, Ravenhall, Vic 3023 Email: info@geolab.com.au Phone: (03) 8361 9140	
	CLIENT: SYMON BROS LOCATION: Botanical, Stage 27 Sketch indicating compaction test locations	DATE: 5/03/2025 OPERATOR: CC SCALE: NTS
