LEVEL ONE

SURVEILLANCE

AND INSPECTION REPORT

Project Name: Maple Grove, Stage 2

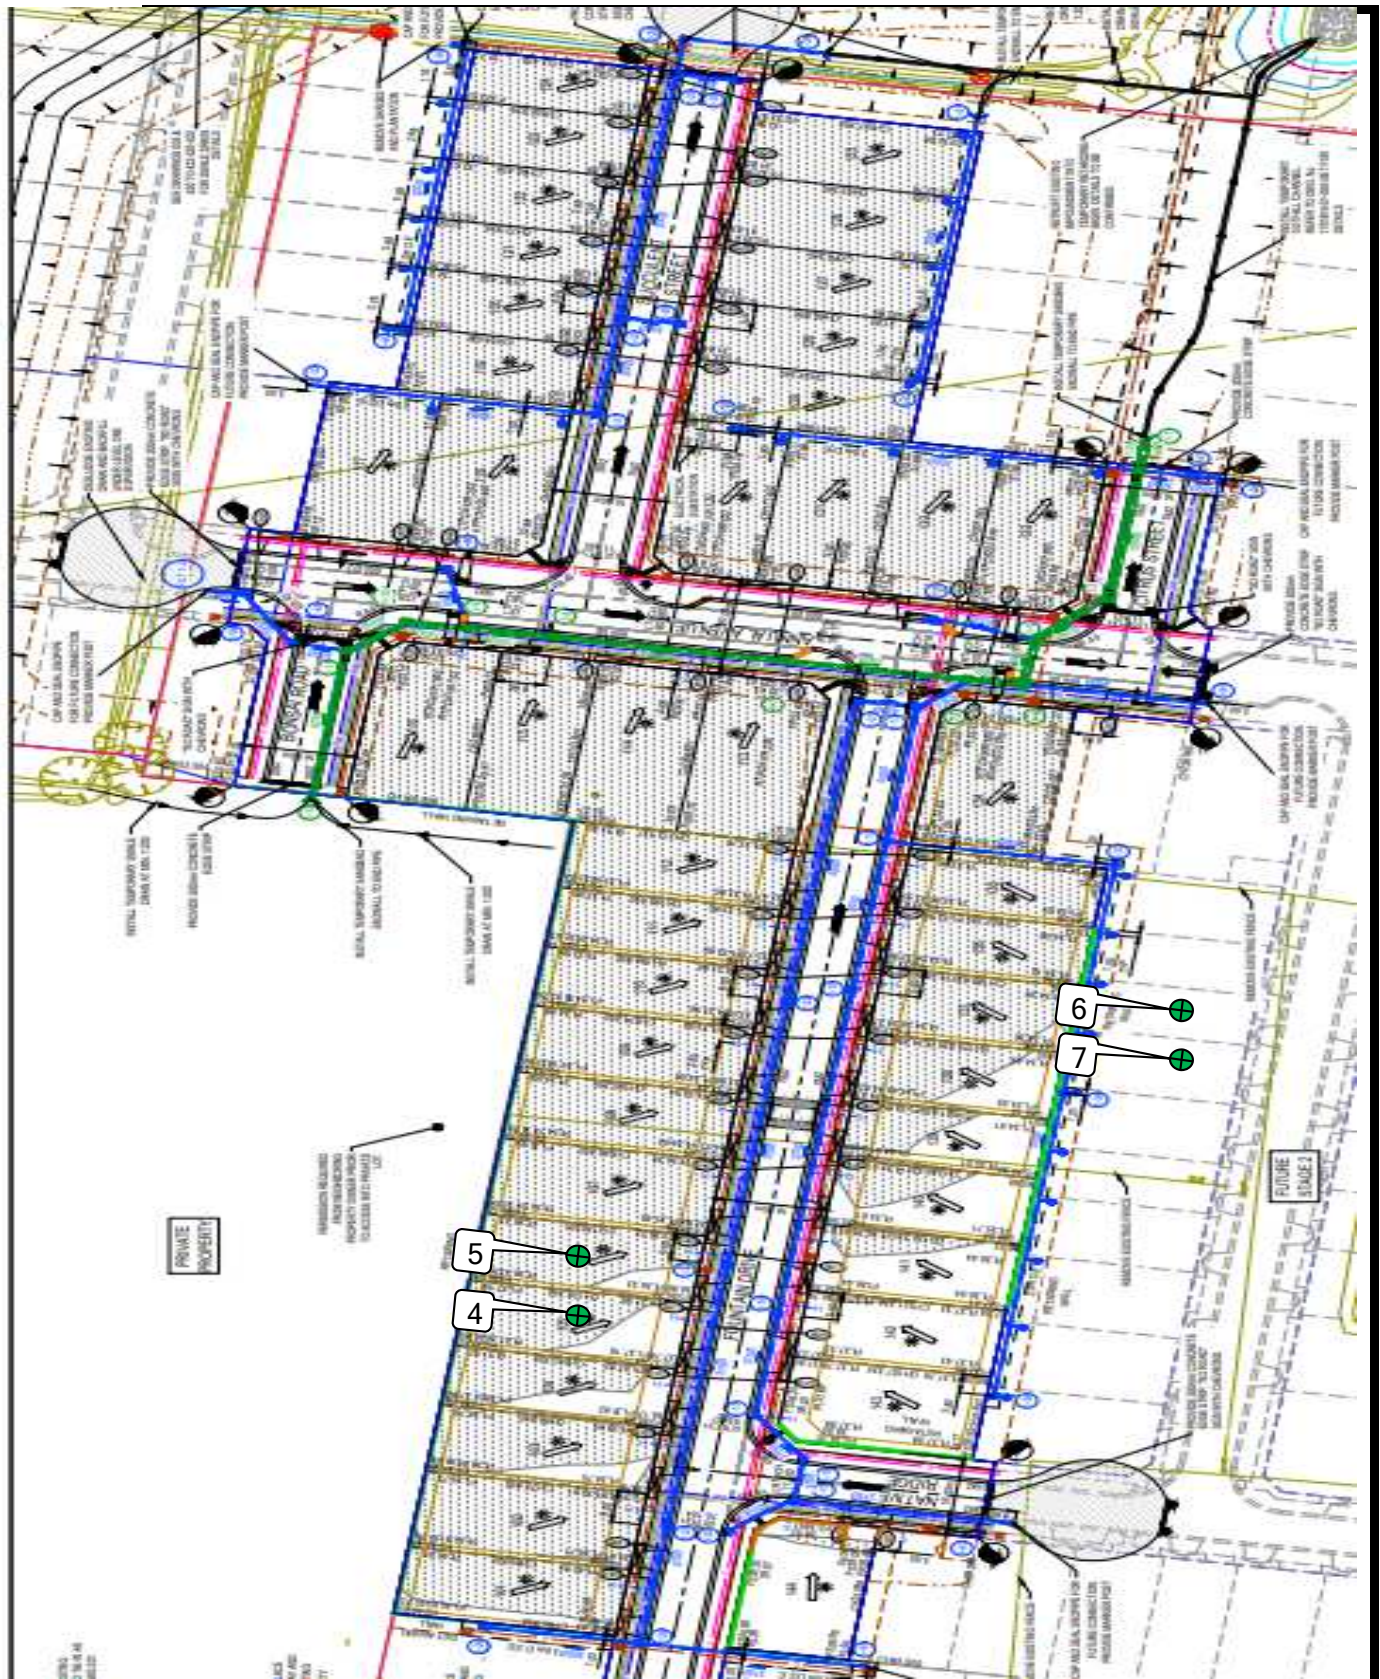
**Sketch indicating compaction test locations**

DATE OF TESTS	TEST NUM.	TEST LOCATION	FIELD WET DENSITY (t/m <sup>3</sup> )	FIELD MOISTURE CONTENT (%)	HILF DENSITY RATIO STANDARD (%)	STANDARD PCWD OR APCWD (t/m <sup>3</sup> )	STANDARD OPTIMUM MOISTURE CONTENT (%)	PROBE DEPTH SETTING (mm)	VARIATION FROM OPTIMUM MOISTURE CONTENT (%)	MOISTURE RATIO (%)	WET +19mm (%)	WET +37.5mm (%)	APPROX. DEPTH BELOW FINISH LEVEL (mm)
20/04/23	4	<b>Refer to #9087/007 for approx. test site locations.</b>	2.10	25.0	102.5	✱ 2.05	24.0	175	0.5 Wetter	103.0	15	0	750
20/04/23	5		2.11	25.5	103.5	✱ 2.04	24.5	175	1.0 Wetter	104.0	16	0	750
20/04/23	6		1.95	28.0	101.0	1.93	27.0	175	1.0 Wetter	104.0	0	0	400
20/04/23	7		1.97	27.5	102.0	1.93	26.5	175	1.0 Wetter	103.0	0	0	400
-	-		-	-	-	-	-	-	-	-	-	-	-
-	-		-	-	-	-	-	-	-	-	-	-	-

A Hilf Rapid Compaction test was carried out on a sample taken from each Field Density location to obtain the Compaction Parameters tabulated on this Report.

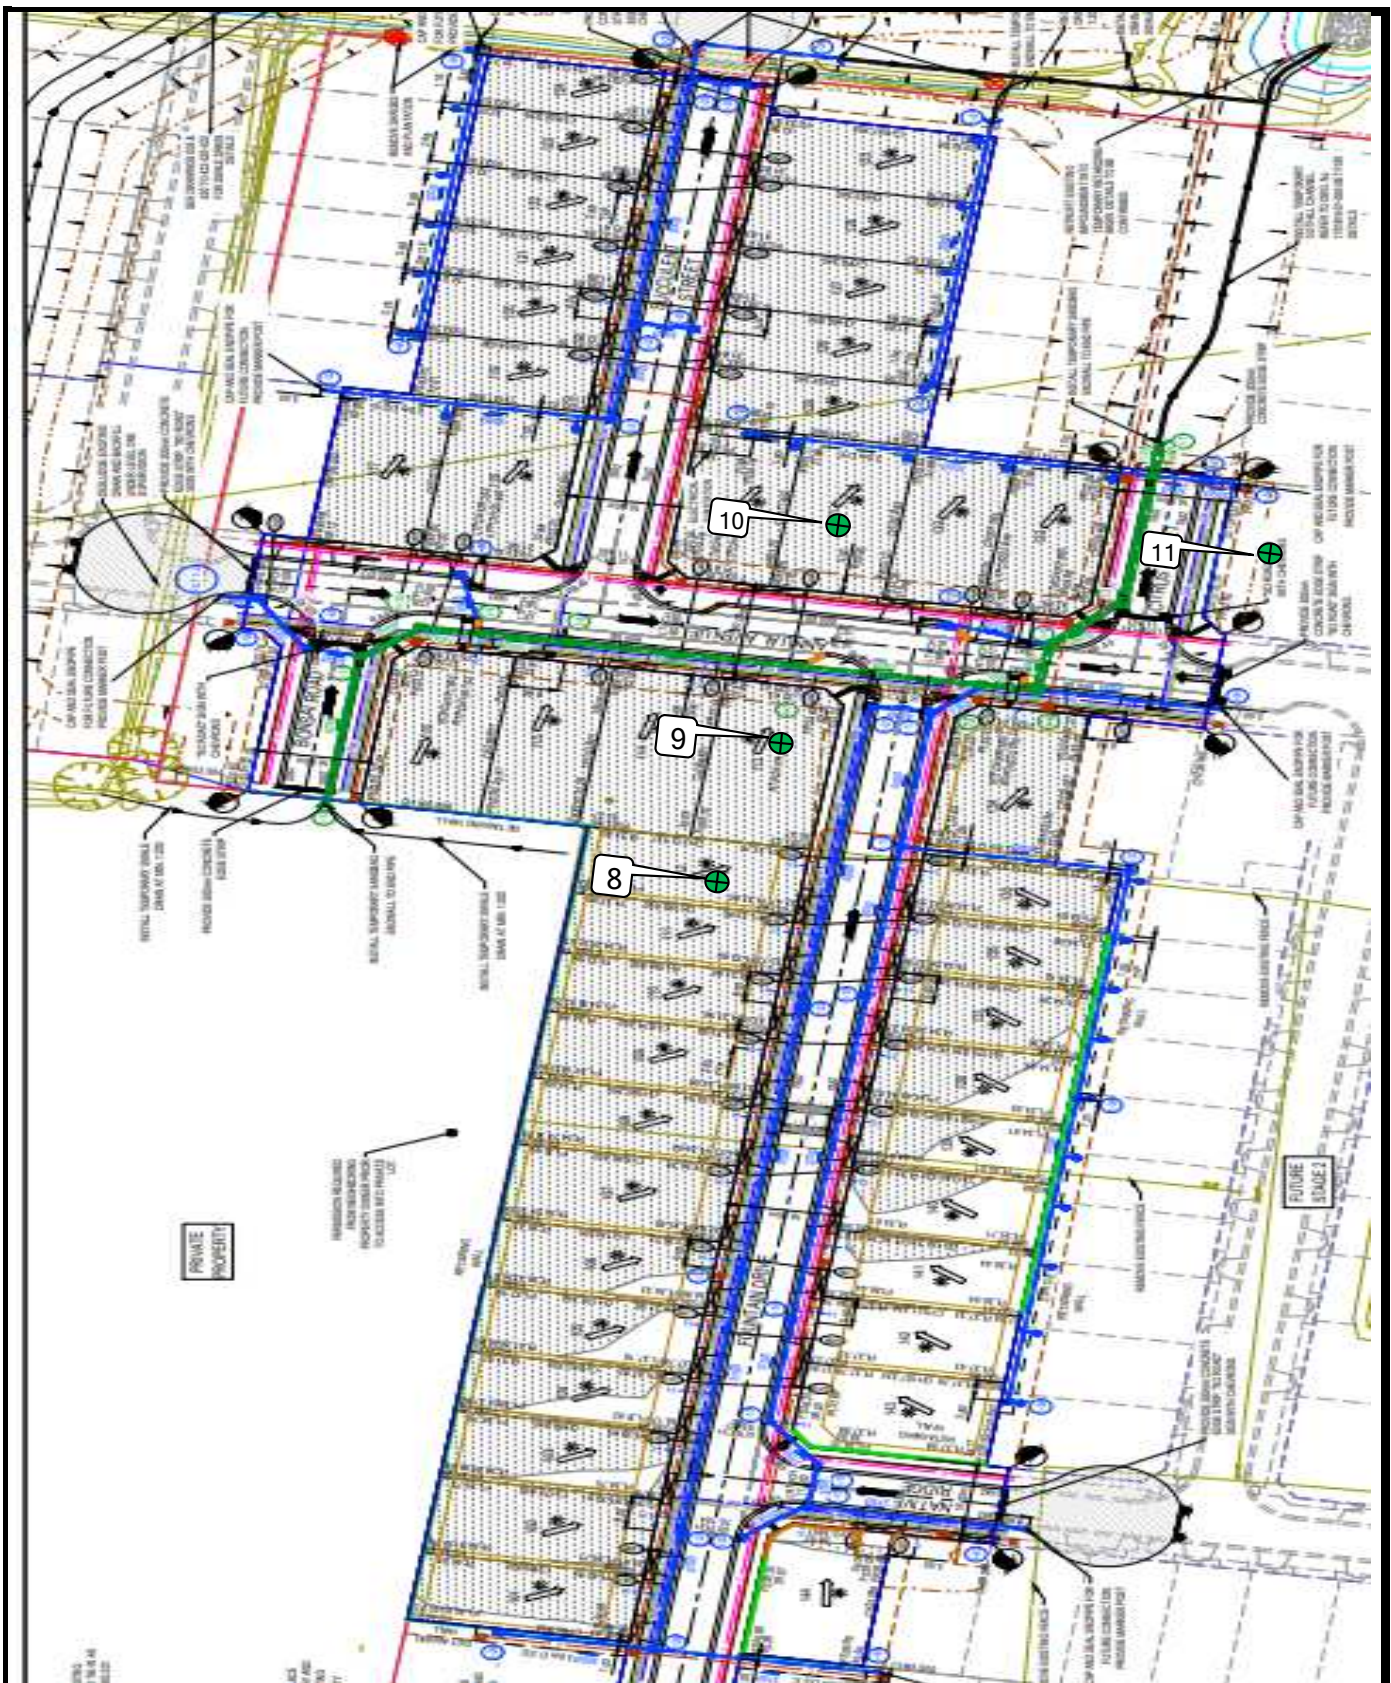
**Sketch indicating compaction test locations**

DATE OF TESTS	TEST NUM.	TEST LOCATION	FIELD WET DENSITY (t/m <sup>3</sup> )	FIELD MOISTURE CONTENT (%)	HILF DENSITY RATIO STANDARD (%)	STANDARD PCWD OR APCWD (t/m <sup>3</sup> )	STANDARD OPTIMUM MOISTURE CONTENT (%)	PROBE DEPTH SETTING (mm)	VARIATION FROM OPTIMUM MOISTURE CONTENT (%)	MOISTURE RATIO (%)	WET +19mm (%)	WET +37.5mm (%)	APPROX. DEPTH BELOW FINISH LEVEL (mm)
21/04/23	8	<b><i>Refer to #9087/013 for approx. test site locations.</i></b>	1.92	27.5	99.0	1.93	27.0	175	0.5 Wetter	101.0	0	0	1300
21/04/23	9		1.98	27.5	103.0	1.92	27.5	175	0.0 Drier	100.0	0	0	1300
21/04/23	10		1.83	31.0	101.0	1.82	32.5	175	1.5 Drier	95.0	0	0	900
21/04/23	11		1.92	30.5	105.5	1.82	32.5	175	2.0 Drier	93.5	0	0	0
-	-		-	-	-	-	-	-	-	-	-	-	-
-	-		-	-	-	-	-	-	-	-	-	-	-

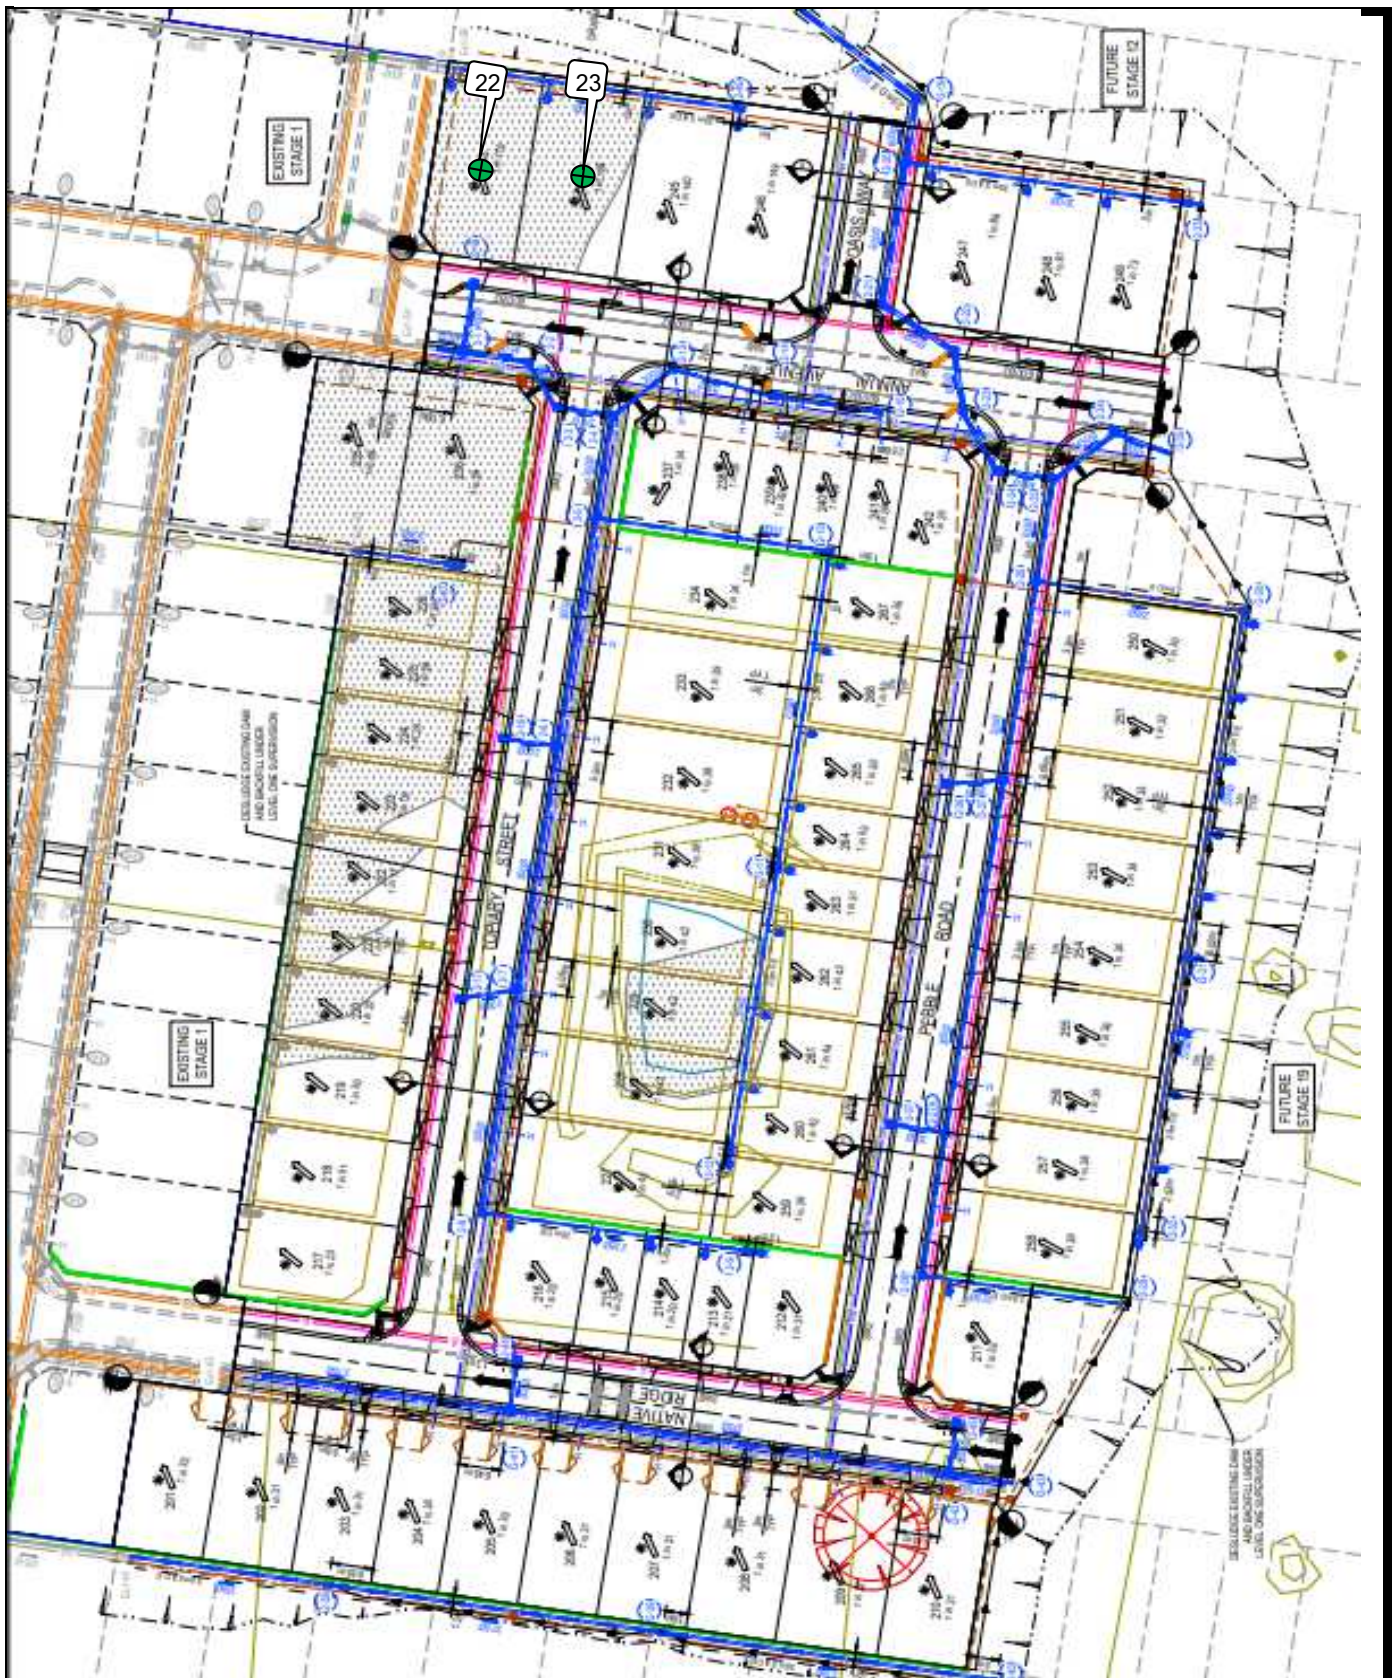
**FIGURE No: 1 of 2**

DATE OF TESTS	TEST NUM.	TEST LOCATION	FIELD WET DENSITY (t/m <sup>3</sup> )	FIELD MOISTURE CONTENT (%)	HILF DENSITY RATIO STANDARD (%)	STANDARD PCWD OR APCWD (t/m <sup>3</sup> )	STANDARD OPTIMUM MOISTURE CONTENT (%)	PROBE DEPTH SETTING (mm)	VARIATION FROM OPTIMUM MOISTURE CONTENT (%)	MOISTURE RATIO (%)	WET +19mm (%)	WET +37.5mm (%)	APPROX. DEPTH BELOW FINISH LEVEL (mm)
2/05/23	22	<b><i>Refer to #9087/023 for approx. test site locations.</i></b>	2.00	27.0	104.5	1.92	27.0	175	0.0 Drier	100.0	0	0	400
2/05/23	23		1.92	28.5	103.5	1.85	30.5	175	1.5 Drier	95.0	0	0	100
2/05/23	24		1.91	29.5	101.0	1.88	29.0	175	0.5 Wetter	101.0	0	0	1000
2/05/23	25		1.96	28.5	103.0	1.90	28.0	175	0.5 Wetter	102.0	0	0	1000
-	-		-	-	-	-	-	-	-	-	-	-	-
-	-		-	-	-	-	-	-	-	-	-	-	-

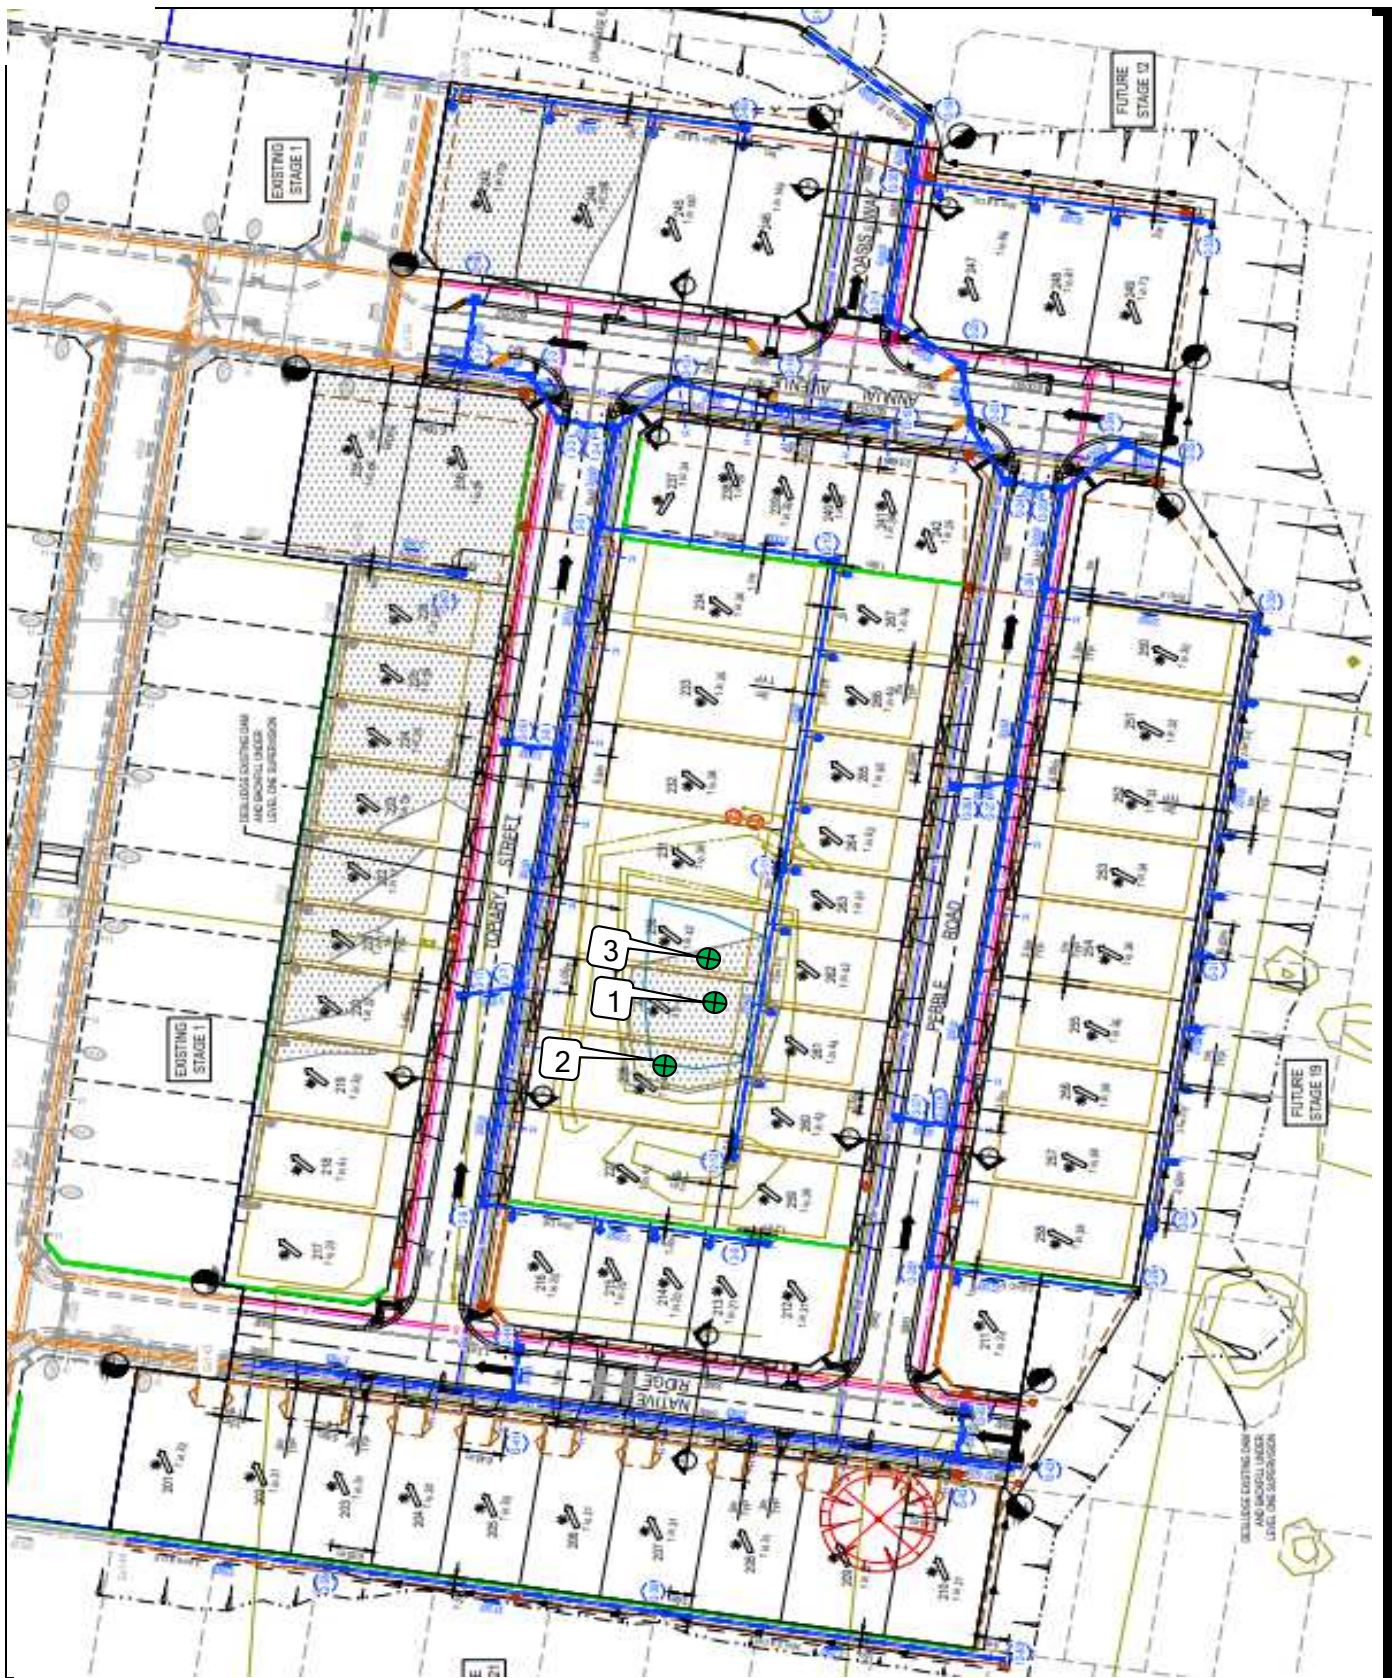
**Sketch indicating compaction test locations**

DATE OF TESTS	TEST NUM.	TEST LOCATION	FIELD WET DENSITY (t/m <sup>3</sup> )	FIELD MOISTURE CONTENT (%)	HILF DENSITY RATIO STANDARD (%)	STANDARD PCWD OR APCWD (t/m <sup>3</sup> )	STANDARD OPTIMUM MOISTURE CONTENT (%)	PROBE DEPTH SETTING (mm)	VARIATION FROM OPTIMUM MOISTURE CONTENT (%)	MOISTURE RATIO (%)	WET +19mm (%)	WET +37.5mm (%)	APPROX. DEPTH BELOW FINISH LEVEL (mm)
11/05/23	1	<b>Refer to #9093/005 for approx. test site locations.</b>	2.02	25.0	103.5	1.95	24.0	175	1.0 Wetter	104.0	0	0	1000
11/05/23	2		1.93	28.5	103.0	1.87	28.0	175	0.5 Wetter	101.0	0	0	1000
11/05/23	3		1.92	31.5	106.0	1.81	33.5	175	2.0 Drier	94.5	0	0	600
-	-		-	-	-	-	-	-	-	-	-	-	-
-	-		-	-	-	-	-	-	-	-	-	-	-
-	-		-	-	-	-	-	-	-	-	-	-	-

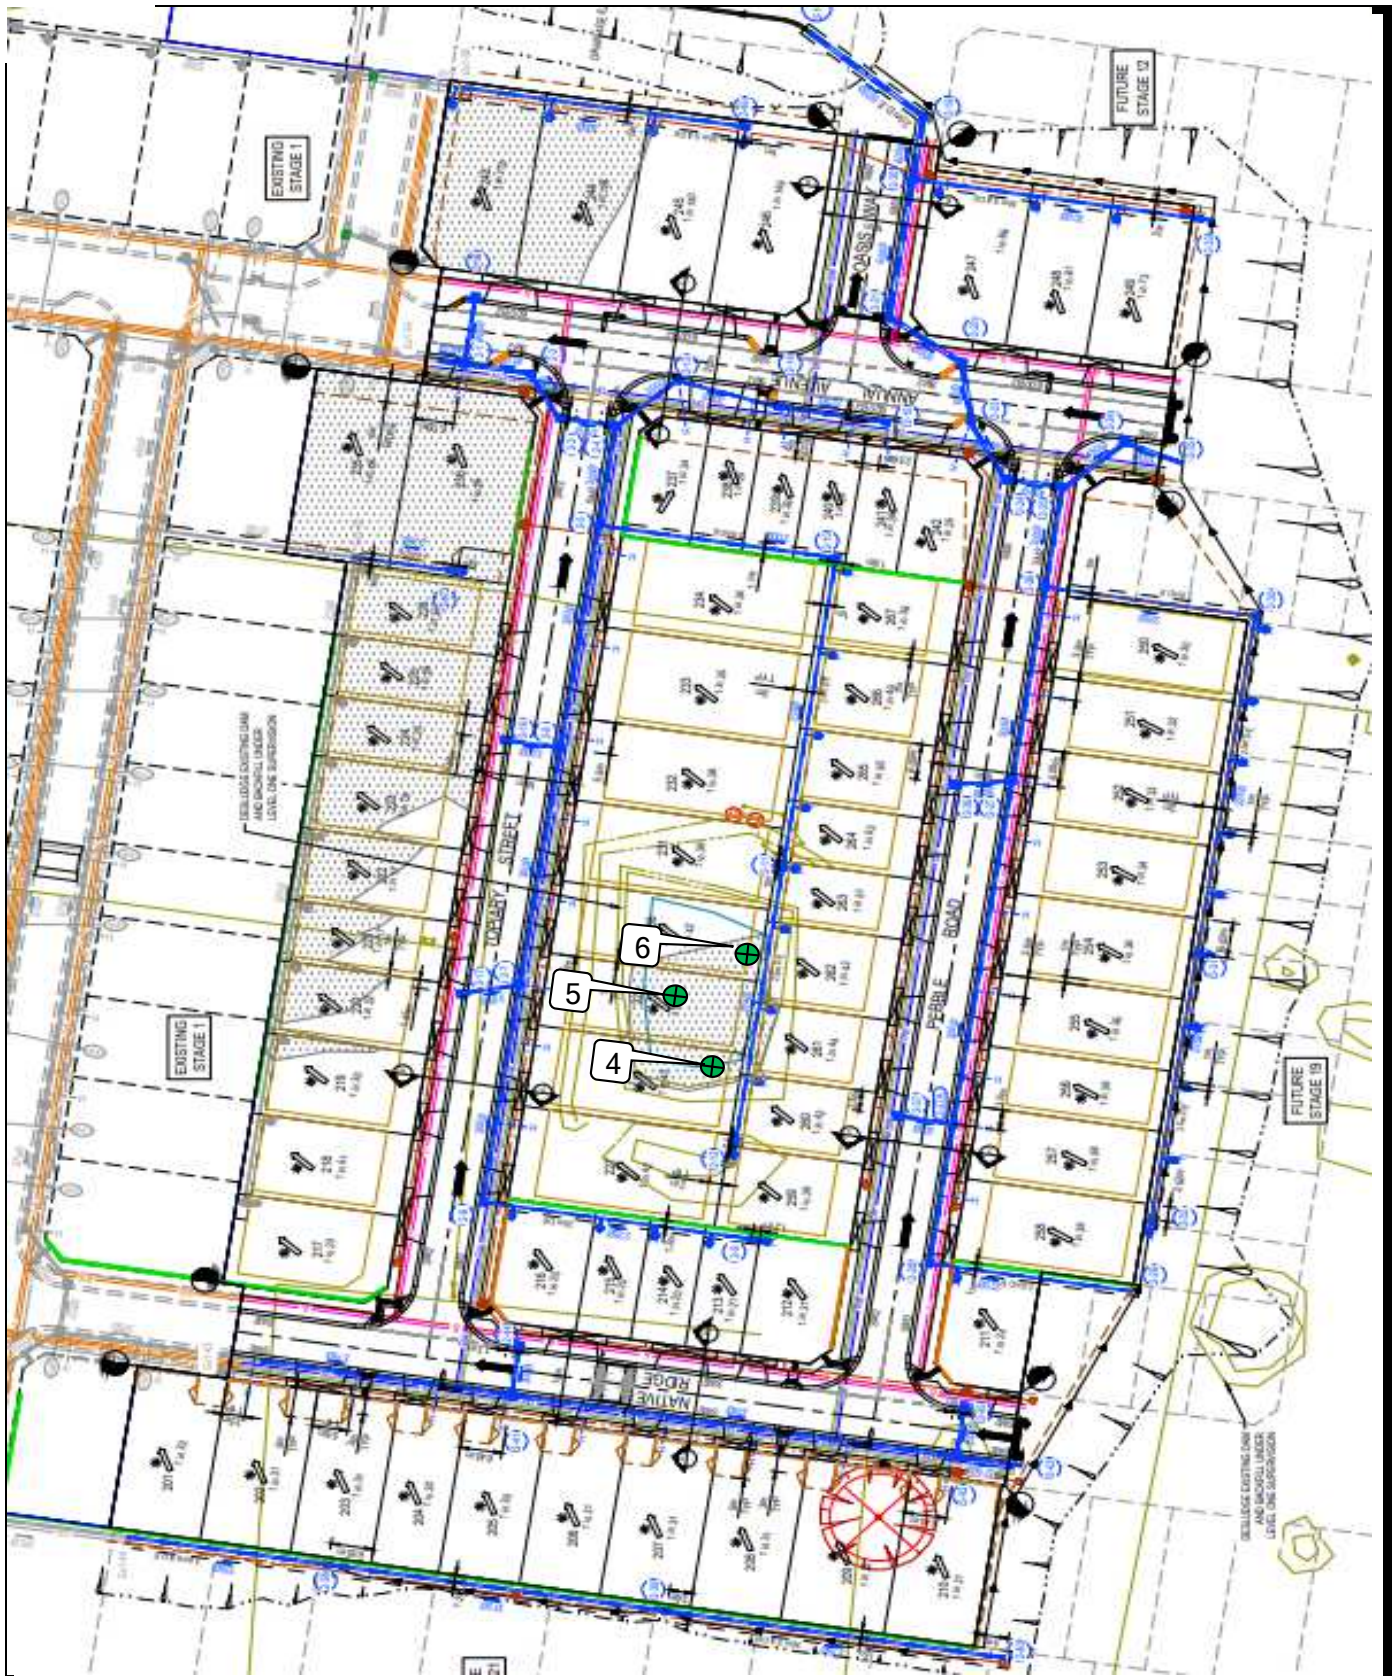
**Sketch indicating compaction test locations**

DATE OF TESTS	TEST NUM.	TEST LOCATION	FIELD WET DENSITY (t/m <sup>3</sup> )	FIELD MOISTURE CONTENT (%)	HILF DENSITY RATIO STANDARD (%)	STANDARD PCWD OR APCWD (t/m <sup>3</sup> )	STANDARD OPTIMUM MOISTURE CONTENT (%)	PROBE DEPTH SETTING (mm)	VARIATION FROM OPTIMUM MOISTURE CONTENT (%)	MOISTURE RATIO (%)	WET +19mm (%)	WET +37.5mm (%)	APPROX. DEPTH BELOW FINISH LEVEL (mm)
12/05/23	4	<b><i>Refer to #9093/007 for approx. test site locations.</i></b>	2.02	21.0	100.0	2.02	20.5	175	0.0 Wetter	101.0	0	0	650
12/05/23	5		1.98	26.5	101.0	1.96	25.5	175	1.0 Wetter	104.0	0	0	250
12/05/23	6		2.04	25.5	105.5	1.94	25.5	175	0.0 Drier	100.0	0	0	300
-	-		-	-	-	-	-	-	-	-	-	-	-
-	-		-	-	-	-	-	-	-	-	-	-	-
-	-		-	-	-	-	-	-	-	-	-	-	-
